# Monitoring strategy – Diagnosing gearbox damage

## Monitoring strategy – Diagnosing gearbox damage

### Diagnosing a fault in a 3-stage gearbox

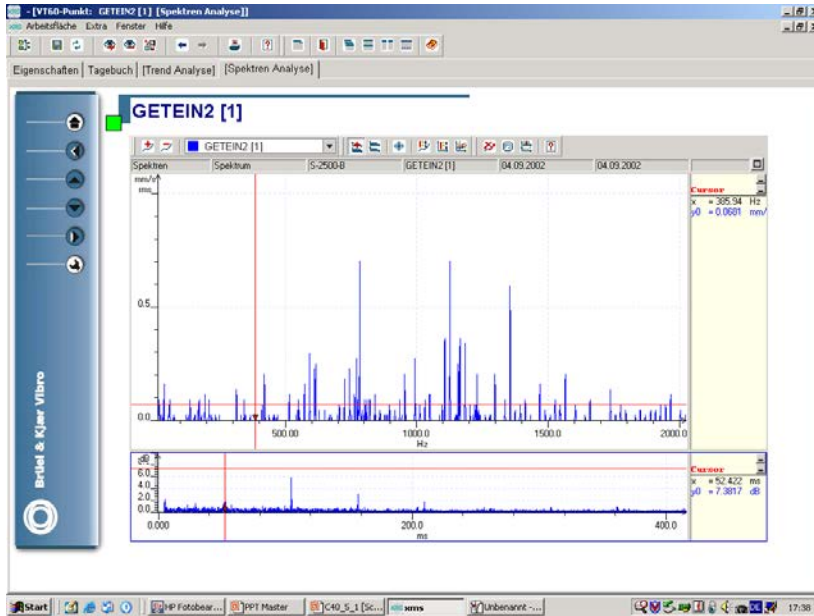
Figure 2. Spectrum and resultant Cepstrum in terms of vibration velocity.

Cepstrum was also post-processed. This is a sensible step due to the fact that acceleration forces in gearboxes are sometimes higher than vibration velocity forces. However this spectrum produced no additional information than shown by the vibration velocity spectrum and was thus also not useful to definitively diagnose the source of the fault.

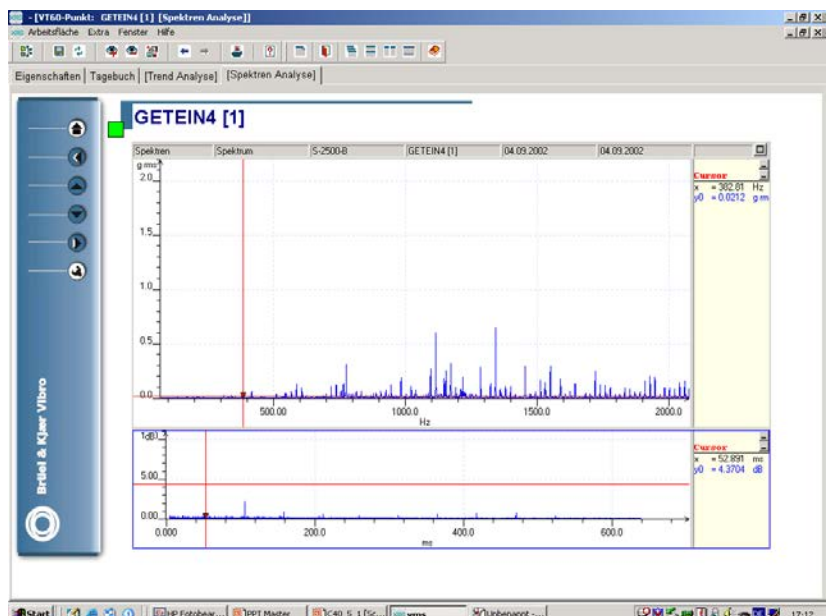
Figure 3. Spectrum and Cepstrum in terms of vibration acceleration.

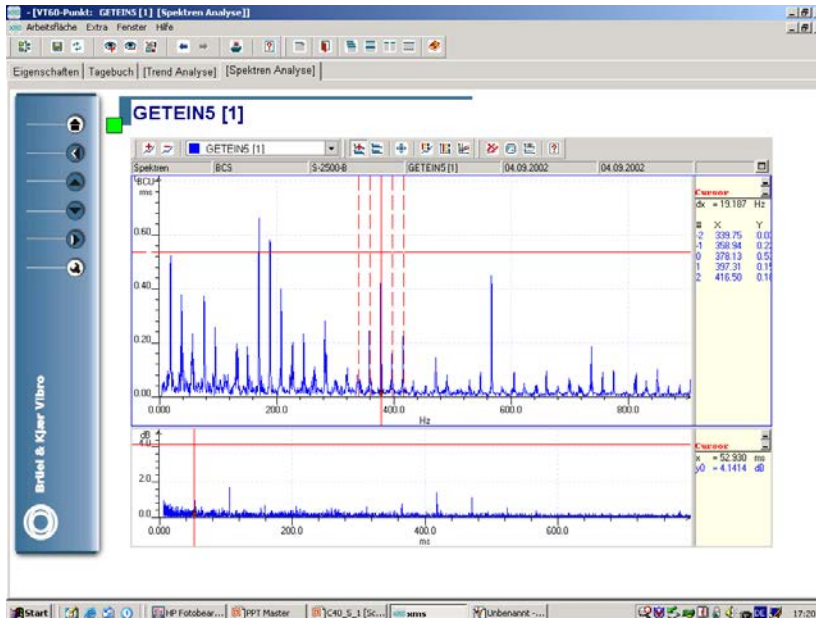
Figure 4. BCS envelope spectrum showing clear sideband activity around approximately 378 Hz.

The initial BCS envelope spectrum – which is based upon the BCU value – and its resultant Cepstrum, showed clear evidence of regular impacts taking place in the gearbox.

The sideband cursor, centred at the 378 Hz tooth-mesh frequency of the input gear in the envelope spectrum in Figure 4, shows the regular impact activity modulating the 378 Hz signal with a 19.187 Hz signal. Note that the tooth-mesh was slightly off the calculated frequency of 384 Hz. This is obviously due to small changes to the input speed of the gearbox.

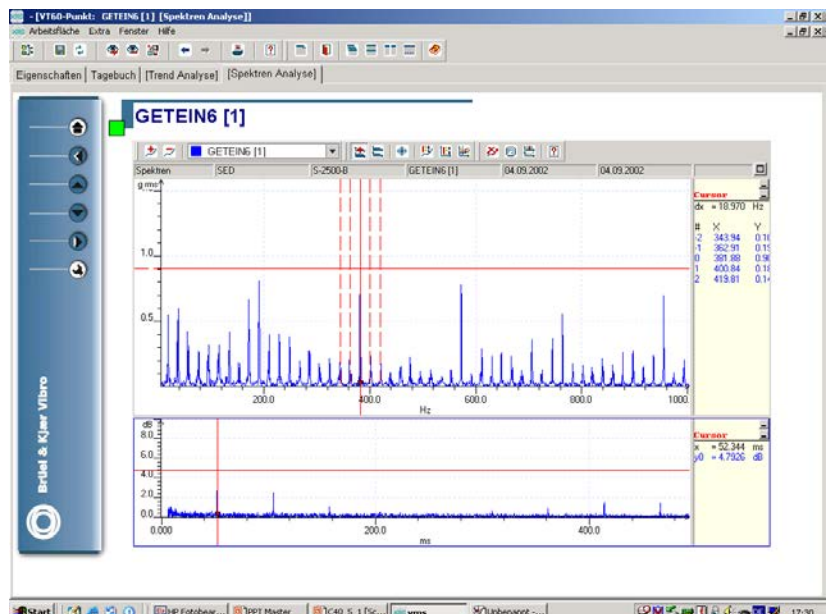
Figure 5. SED envelope spectrum confirming the result of the BCS envelope spectrum.

was acquired known as an SED (selective envelope detection). This type of envelope spectrum differs only in that the filter frequency range for the measurement is adjustable whereas in the case of the BCS envelope spectrum the high-frequency bandpass filter has a fixed frequency range. The results, as shown in Figure 5, are almost identical to the BCS envelope spectrum.

At the time of the measurement the input speed of the gearbox had again changed slightly, evident by the tooth-mesh frequency at 381 Hz, and the sideband activity is clearly shown at a frequency of approximately 18.97 Hz either side of the tooth-mesh frequency.

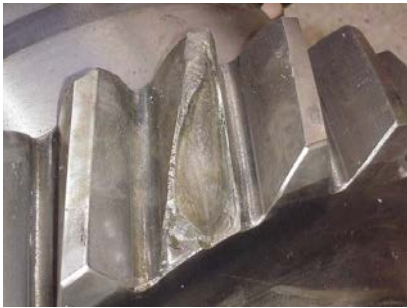
Figure 6. The broken tooth section of the pinion gear.

The approximately 19 Hz sidebands around the tooth-mesh frequency of 384 Hz was a strong indicator that the input gear was damaged in some way and was producing impacts that had caused the sudden and large increase in the BCU value.

Upon examination of the input gear it was found that a relatively large section of one of the teeth on the pinion gear had broken away. This produced an impact at the rotational frequency of the gear which had so dramatically increased the BCU value.
