**Case study – Off-line monitoring played an important role at the Ignalina nuclear power station**

# Case study – Off-line monitoring played an important role at the Ignalina nuclear power station

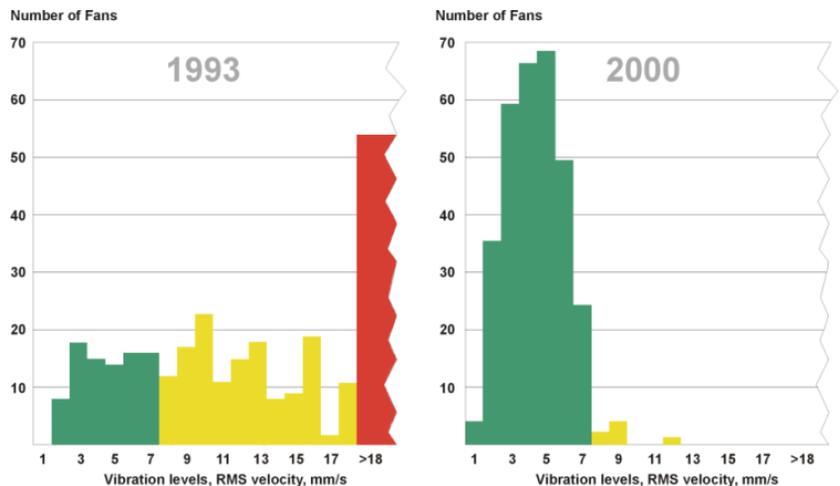
Figure 3. Offline monitoring has considerably reduced maintenance on the 897 fans. The number of fans operating within the allowable vibration levels (shown as green) according to ISO 2372 in 2000 has increased significantly since 1993.

It was determined that only about 30% of the fans in the plant were operating within the acceptable vibration limits when the Vibro-diagnostic Laboratory was started, as seen in Figure 3. Around 30% of the fans were actually operating in the unacceptable zone due to various problems such as unbalance, misalignment and wear! This often resulted in bearings failing prematurely. This problem has since been corrected by implementing an effective off-line monitoring strategy. Most of the high vibrations at the fans were due to unbalance, worn bearings or misalignment, but the excessive vibration detected on the horizontal belt-driven fans was due to other reasons. It was later determined that the vibration problem for these type of fans could only be eliminated by stiffening the support structure of the belt drive, as shown in Figure 4.

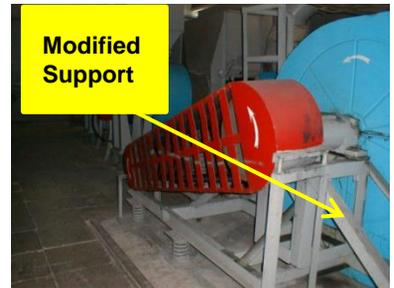
Figure 4. Horizontal belt-drive support modification for those fans that had excessive vibrations due to lack of structural stiffness.

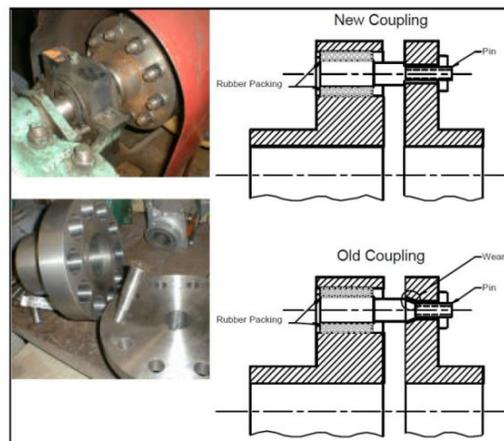
Figure 6. Flexible coupling of the accident confinement system pump showing newly designed pump-end flange and bolts.

Inspection after disassembly revealed that the pump-end coupling flange had worn coupling bolts and bolt holes. This extra transverse clearance resulted in excessive vibrations. Further investigation revealed that there was similar wear on all the accident-confinement pumps. The coupling design was changed as shown in Fig. 6. The CPB spectrum before and after implementing the new coupling design on one of the pumps is shown in Figure 7.

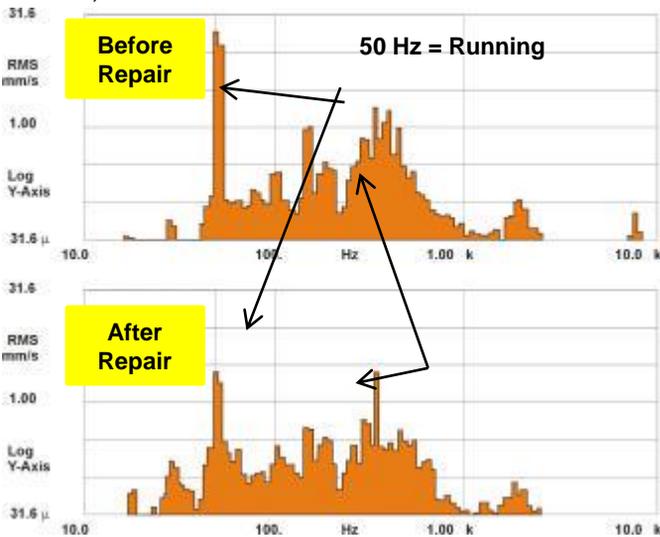
Figure 9. CPB spectrum of the purification and cooling system pump before (above) and after (below) replacing the impeller.

Excessive vibration was detected at the running speed and the blade-pass frequency for both pumps on both reactor units. The high vibration amplitude, especially of the running speed component,

is shown in the top CPB spectrum in Figure 9. The vibration amplitude of the running speed component after replacement of the impeller is shown in the bottom CPB.

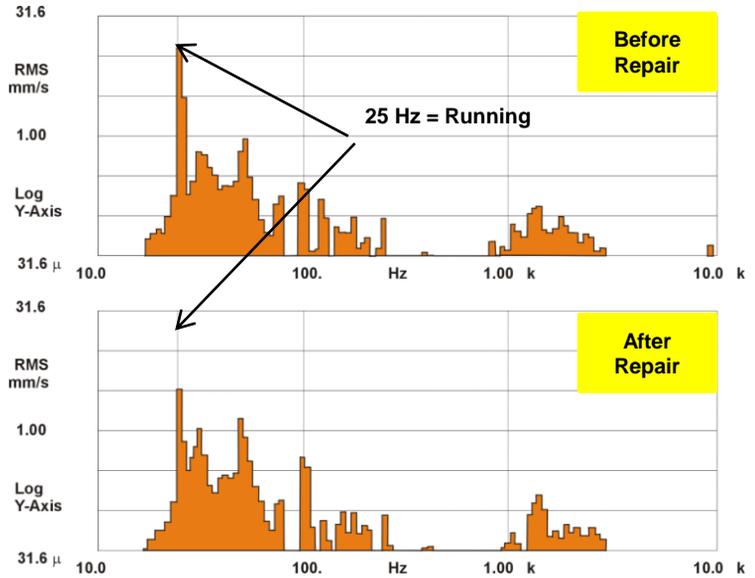
After measurements were taken one day on one of the accident-confinement pumps, it was seen that after repair the running frequency vibration amplitudes had increased from 4-7 mm/s to 13-18 mm/s on the bearing housing on one of the pumps (see top in Figure 7).

Figure 7. Constant percentage bandwidth spectrum (CPB) of the accident containment system pump before (above) and after (below) replacing the coupling with a new design.

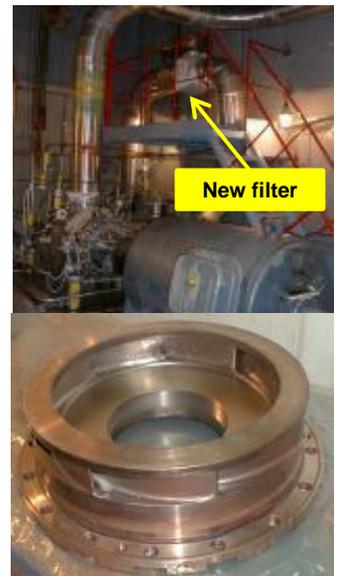
Figure 8. There are two purification and cooling system pumps for each reactor unit. Each 500-kW motor-driven pump has a flow capacity of 500 m<sup>3</sup>/hr at 3000 rpm. A damaged shroud is shown to the below.

The suspicion that the impellers were damaged was verified upon opening the pumps.

Examination revealed that the impeller and shroud were damaged by foreign metal object ingestion (see Figure 8). To prevent a future recurrence of the same type of problem from metal particles passing through the pump special filters were installed on the suction side.

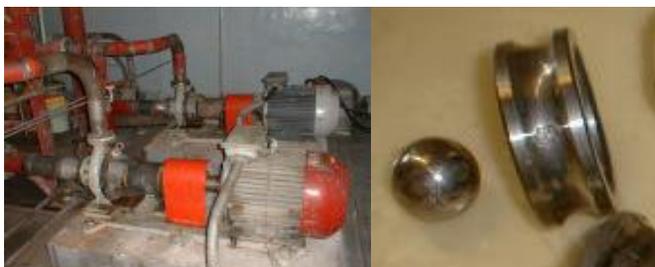
The replaced bearing was disassembled and examined to confirm the damage to the inner race. Figure 10 shows the premature damage on the inner race that had begun to spread to the rolling-elements.

Figure 10. There are three demineralized contaminated water pumps for each reactor unit. Each 55 kW motor-driven pump has a flow capacity of 90 m<sup>3</sup>/hr at 3000 rpm. Damaged bearings are shown in the picture to the left.

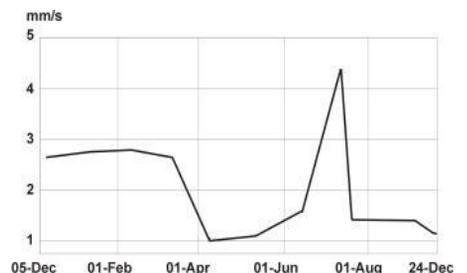
In Figure 11 the overall vibration level trend can be seen for bearing N4 on one of the pumps between December 2000 to September 2001. Up until April 2001, the overall vibration was approx. 2.7 mm/s. The pump was serviced in April, after which the vibration was reduced to 1.1 mm/s. However between June 14 and July 11 the vibration suddenly increased from 1.6 to 4.3 mm/s.

Figure 11. Vibration on the N4 bearing of the pump has increased from 1.6 mm/s June 14 to 4.3 mm/s July 14.

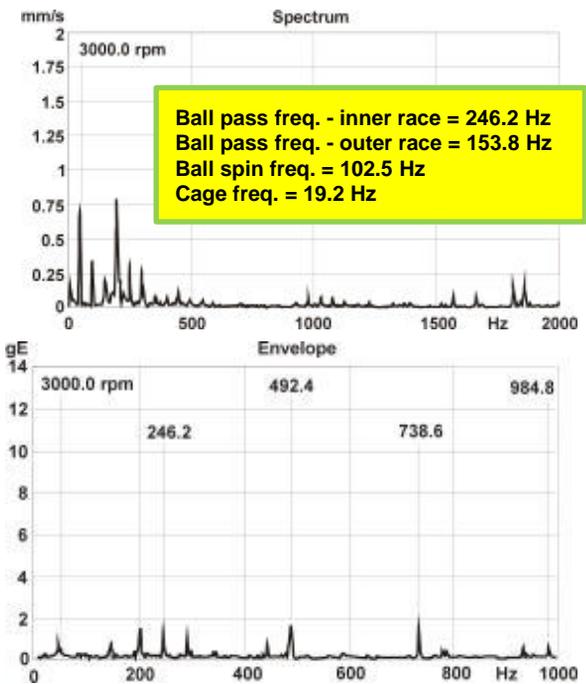
As indicated by the diagram in Figure 12, the envelope spectrum measured on June 14 already showed early signs of damage to the inner race of the bearing (246.2 Hz) and its harmonics (492.4; 738.6 and 984.8 Hz).

Figure 12. Before Repair (June 14): There is already evidence of damage to the inner ball bearing race as seen by the prominent ball passing frequency for the inner race (246.2 Hz) and its harmonics (492.4, 738.6 and 984.8 Hz).

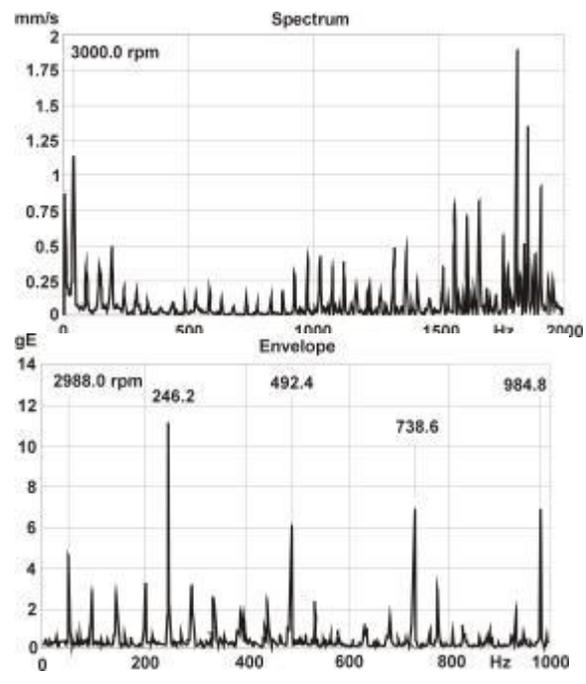
As the damage progressed, the envelope spectrum showed increased vibration amplitudes in the high frequency range. The ball-pass frequency and its harmonics for the inner race are clearly seen in the envelope spectrum diagram in Figure 13 below.

Figure 13. Before Repair (July 1): As the damage progresses, the spectrum plot shows increased vibration amplitude in the high frequency range. The ball passing frequency for the inner race and its harmonics are clearly seen in the envelope plot.

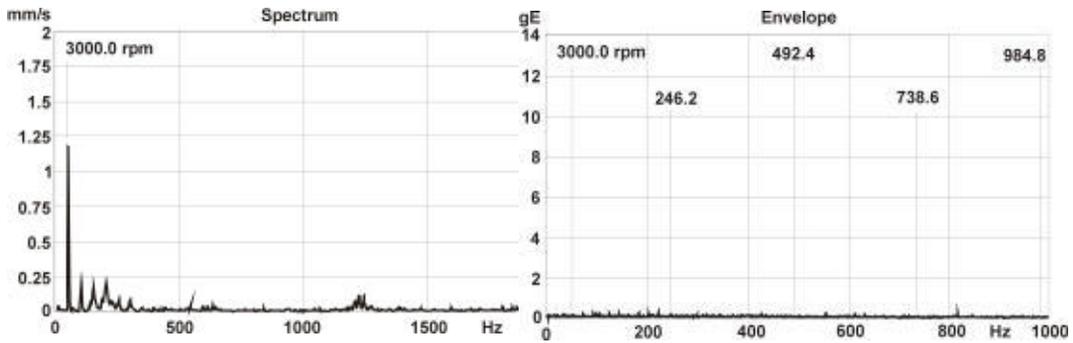
Figure 14. After Repair (July 20): The high frequency vibrations are reduced significantly in the spectrum plot, as are the peaks associated with the ball passing frequency for the inner race and its harmonics in the envelope plot.

After replacement of the damaged bearing, the vibration returned to acceptable limits as shown in Figure 14. The high frequency vibrations and the peaks associated with the ball-pass frequency for the inner race and its harmonics are virtually completely eliminated.
