Application Note

Case study – Monitoring case vibration with an accelerometer on low-speed hydro turbines

BAN 0028-EN-12 Date: 14.10.2014

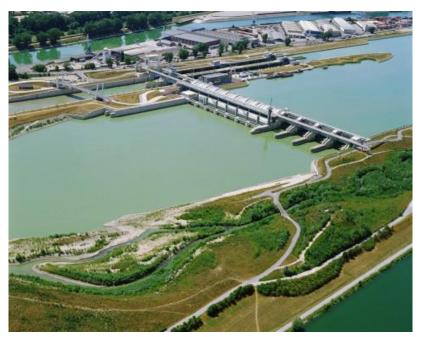
Figure 2. Freudenau hydroelectric power station.

The Compass monitoring system is installed at the Freudenau Hydropower plant near Vienna. The six bulb type horizontal machines have a 7m diameter, so they are among the largest in Europe. Several monitoring techniques are used on the machines, including vibration monitoring. Relative shaft vibration is measured with non-contact displacement sensors while the absolute vibration is monitored with accelerometers. As the turbines are rotating at 65.2 rpm, it is the necessary to monitor at least the 1Hz frequency component in the monitoring spectrum in order to detect and diagnose 1x faults such as unbalance.
