**Case study – On-line monitoring  
strategy at a polyolefin plant  
gives fast results**

# Case study – On-line monitoring strategy at a polyolefin plant gives fast results

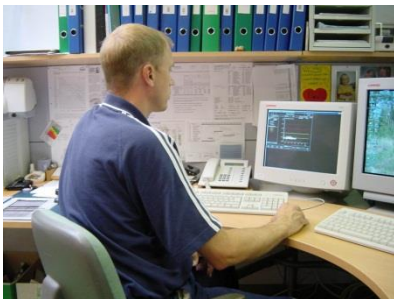
Figure 1. Analysing a plot on the central monitoring system server in the condition monitoring room.

The condition-monitoring group keep an eye on the machines and do diagnoses during normal working hours, as shown in Figure 1. The Control Room Operators also receive vibration alarms on their consoles, so they can alert Maintenance to assess an alarm situation during off hours. Imported vibration information is further routed from the DCS to the process management system, where this information is further trended and correlated together with the DCS process data. The monitoring system server can be

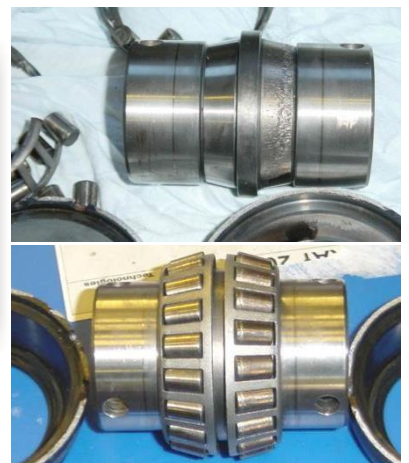
Figure 3. Location (top) and view (right) of the damaged bearing in the centrifugal dryer.

**Defective bottom bearing** - High vibrations were monitored by the on-line system, but the existing portable vibration monitoring instruments used to confirm this indicated normal readings. Maintenance was reluctant to open the machine, but investigation

revealed that the bearing was indeed damaged (see the plots in Figures 4 and 5). Afterwards it was determined that it was difficult to get a good off-line measurement on this bearing because of difficult access.

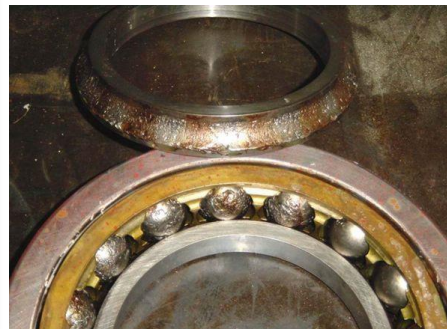
Figure 6. Location (left) and view (right) of the defective reactor mixer motor bearing.

The reactor mixer is a key process component for ensuring proper LDPE polymerization. The bottom bearing of the motor has several times shown signs of a pre-mature failure before its expected lifetime. Although the mechanisms causing this are still being investigated, it is imperative that such a bearing failure be avoided as it can have grave consequences on the 2100 bar pressurized reactor. Pieces of the bearing can obstruct the narrow discharge passageway of the polymer product, which could possibly result in serious damage and extended downtime. For the 14 months the on-line monitoring system has been in operation, there have already been three pre-mature bearing faults detected.
