**Case study – Off-line monitoring played an important role at the Ignalina nuclear power station**

# Case study – Off-line monitoring played an important role at the Ignalina nuclear power station

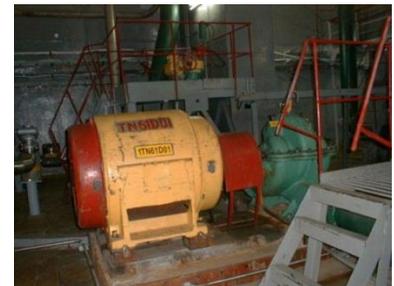
Figure 5. There are six accident confinement pumps for each reactor unit in the condenser tray cooling system. Each 320-kW motor-driven pump has a flow capacity of 1250 m<sup>3</sup>/hr at 1500 rpm.

Inspection after disassembly revealed that the pump-end coupling flange had worn coupling bolts and bolt holes. This extra transverse clearance resulted in excessive vibrations. Further investigation revealed that there was similar wear on all the accident-confinement pumps. The coupling design was changed as shown in Fig. 6. The CPB spectrum before and after implementing the new coupling design on one of the pumps is shown in Figure 7.
